**2A Brown Street Car Park**

**Description**

Public car parking for members of the public. There is limited parking of 3 hours. This car park is monitored by rangers.

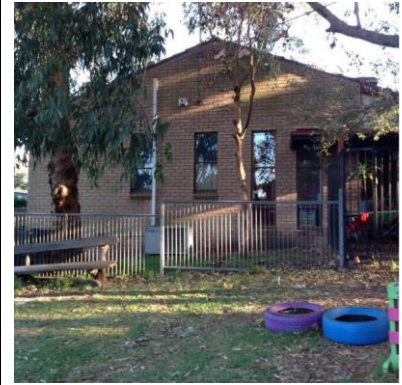
Centre-based education and care service. The building has brick construction, with a tile roof, internal walls are render and ceilings are gyprock currently used as a childcare centre. The centre is made up of several small rooms, staff areas, storage areas, playrooms, kitchen areas and toilet areas.

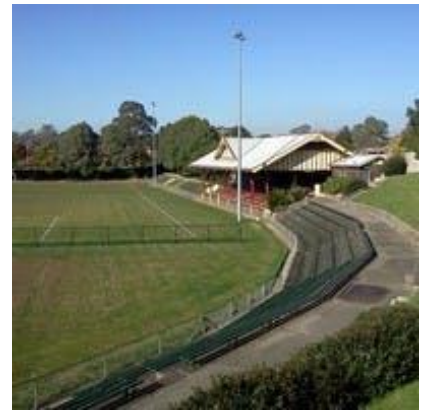
This asset is a concrete structure hosting ten rows of seating over viewing the playing field. The seating are constructed with lacquered Oregon pine screwed into steel chair stands.

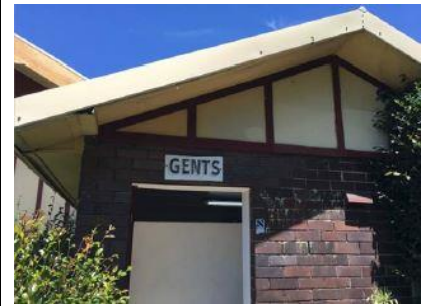
The toilet building is constructed from rendered brick, with a concrete slab roofing area. They provide bot male and female toilets at a very accessible area of the park. Also, the grandstand is cover my a colour bond roof with hardwood timber framework.

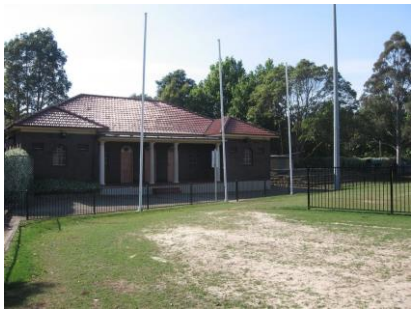
<p><b>Arlington Storage Room</b> <b>Description</b> The building is a single brick veneer structure with clay roof tiles.</p>

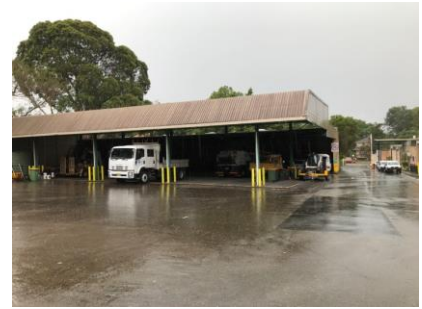
Large steel framed, iron roofed shed covers a large area of yard and provides cover for over twenty vehicles and plant.

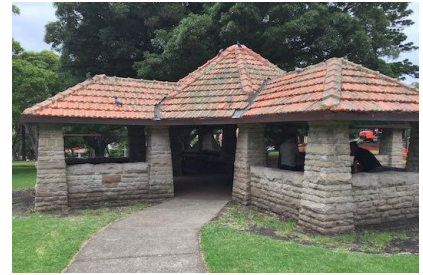
The building is constructed by stone block works. The roof is made of terracotta roof tiles which is held up by timber framework supported by twelve pillars. Inside the house, there are steel benches and tables sitting in a concrete footing.

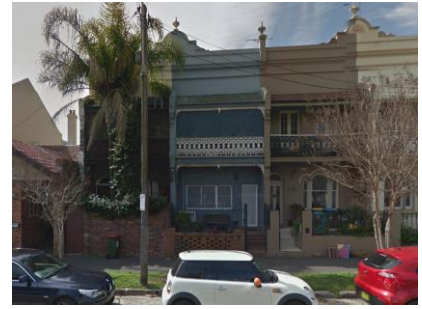
The building is a double storey, brick and render construction and gibrock walls and ceilings for the inside. The building as multi rooms and a top level outdoors area for which the children play in.

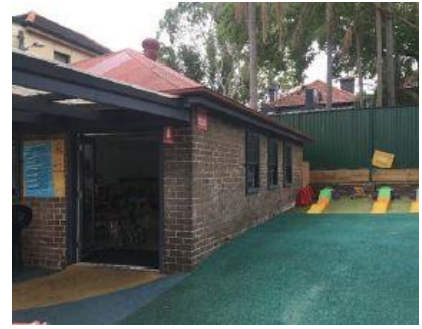
The site has two separate buildings for this child care services. Both buildings are single storey, one building constructed out of single brick veneer and the other fibber board sheeting. Both buildings have colour bond sheet roofs.

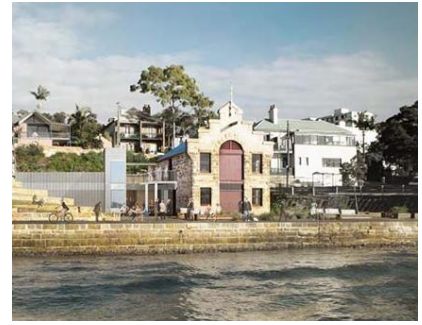
The stone workshop, built by J Fenwick and Co in the early 1880s, is a rare survivor of maritime industry on the East Balmain foreshore. The design and construction of the stone store is characteristic of late 19th century warehouse architecture, although its use of course rubble in its wall construction is unusual.

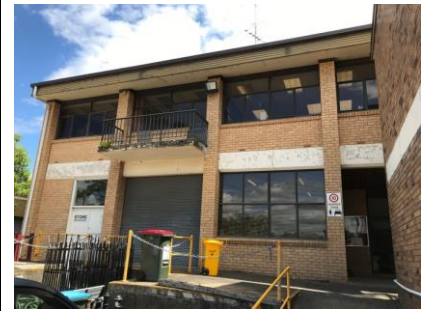
Building Description The Administration building is generally functional but in need of renovation. The records dept. have suggested new compactus units be installed in the downstairs records store as the existing shelving is not compliant. The upstairs office is well worn but only used by two staff.

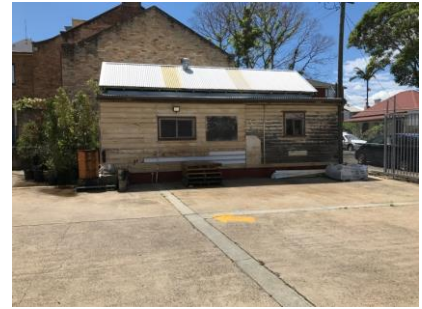
The Gardeners shed is a weatherboard building in poor condition, requiring new cladding in many places where boards are literally falling off.

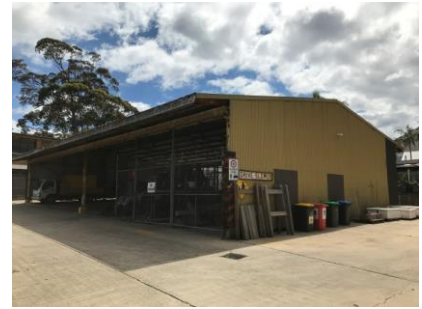
Structure consists of a steel frame with iron roof and iron cladding at north and south ends. Used as under cover parking for trucks and plant and some secure caged storage for fertilizer, soil etc. Some minor damage to iron cladding and guttering but appears safe and stable.

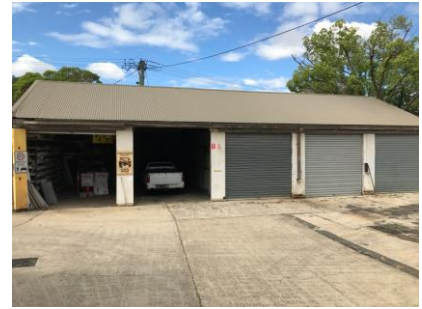
The partitioned garage at Balmain Depot is primarily used for storage and parking for the Community Bus. It is a corrugated iron over steel frame construction. The building is in need of structural repair with extensive rust and corrosion weakening the steel framework.

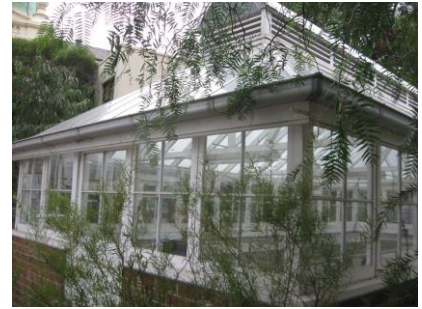
The original glasshouse was built by the then Balmain Council in 1946 for the production of plants to be used in the local parks and reserves. Leichhardt Council in 2005 restored the glasshouse to its former glory to be once again used for propagation of plants by the community for bush care and park improvement projects in the Balmain area.

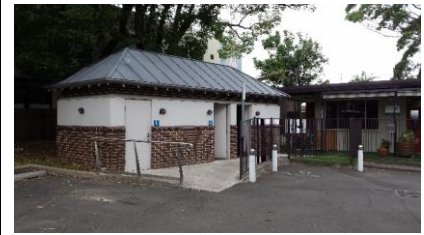
The toilet building is constructed from rendered brick, with a concrete slab roofing area. They provide bot male and female toilets at a very accessible area of the build.

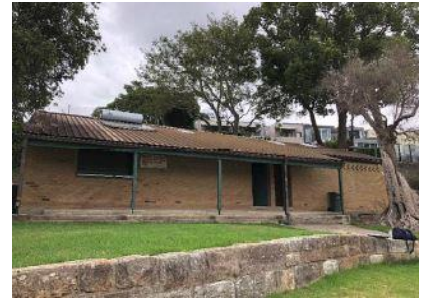
The structure of the amenities is a single storey complex constructed of timber structure and colour bond roof sheets. The grandstand is constructed of timber framework and reinforced by screws and bolts.

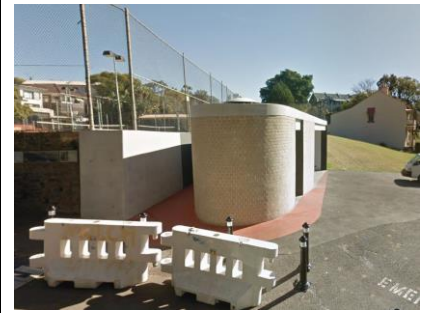
The toilet building is constructed from rendered brick, with a concrete slab roofing area. They provide bot male and female toilets at a very accessible area of the park.

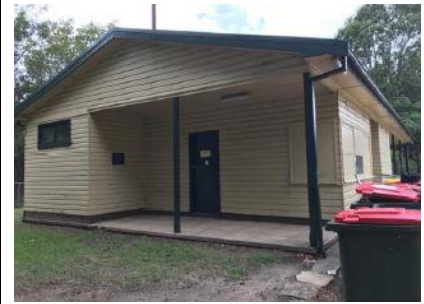
The building structure is constructed of timber framework and hardwood timber cladding painted cream. The roof is made of white colour bond sheets and green aluminium gutters.

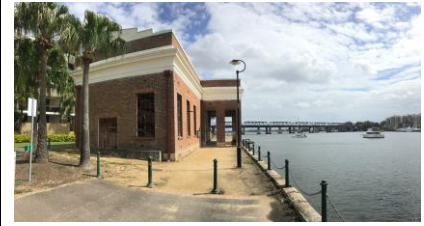
This building stands in Bridgewater Park, beside Iron Cove, in the inner west suburb of Rozelle. It was constructed in 1934 as the pump house for the former Balmain Power Station. Cool water was drawn in from the river and pumped up to the station using electronically driven pumps. The water was used to cool the condensers and was then pumped back into the river. The power station was constructed in 1909 and supplied electricity to the local area until it was decommissioned in 1976. The power station was demolished and the land was redeveloped into residential apartments and this park along the foreshore. The building is constructed by brick veneer with colour bond roof sheets and one a single level.

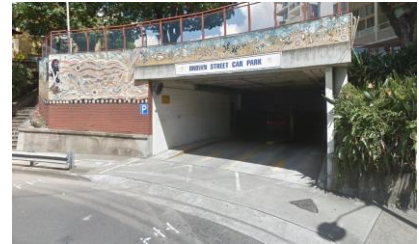
the building is a underground carpark with access from Brown St Ashfield. The carpark is located below the Esplanade.

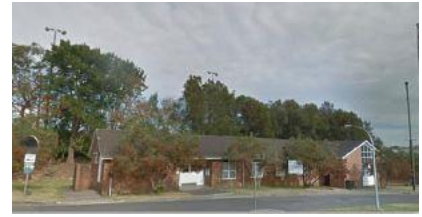
The toilet building is constructed from rendered brick, with a concrete slab roofing area. They provide both male and female toilets at a accessible area of the park.

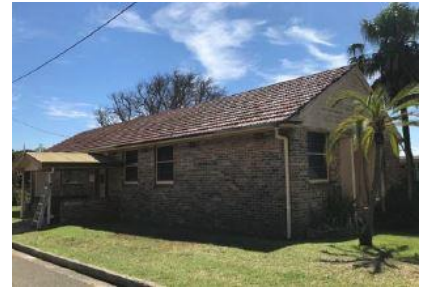
The storage room is located inside the building on Callan Park. The building is constructed of sandstone blokes and slides roof tiles.

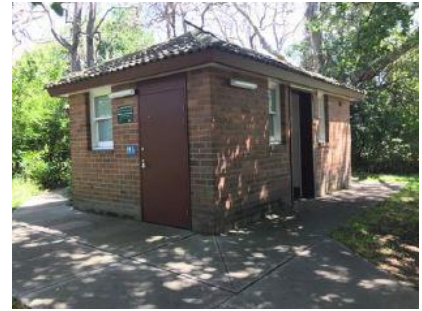
The toilet building is constructed from rendered brick, with a concrete slab roofing area. They provide both male and female toilets at a accessible area of the park.

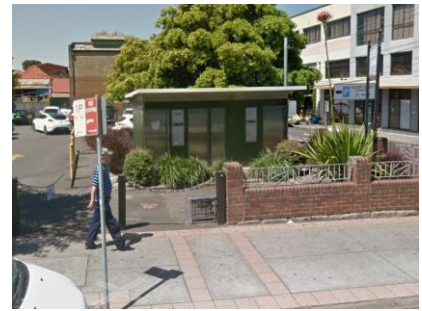
The toilet block has fibrolite construction, with a collarbone roof, internal walls are ceramic tiles and fibrolite ceilings. The toilet block consists of two unisex toilets, a disabled toilet and a plant room.

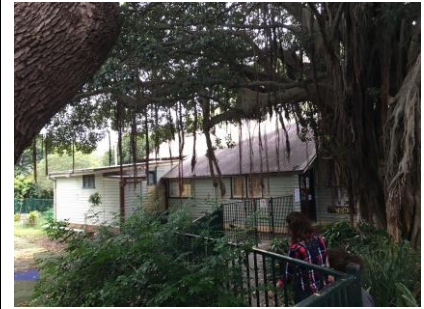
Centre-based education and care service, approved by Department of Education & Communities children of school age. The building has brick construction, with a tile roof, internal walls and ceilings are hardboard. The building is currently used as a childcare centre. The centre is made up of an office, eating and play areas, storage room, toilet area and kitchen.

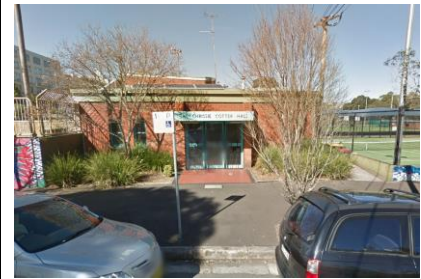
**Chrissie Cotter Gallery**

The building has brick construction, with a aluminium roof, internal walls and ceilings are gyprock. The building is currently used as a public hall. The Hall is made up of the main hall, a kitchen, lobby and foyer areas, a room and toilet areas for male, female and disabled users.

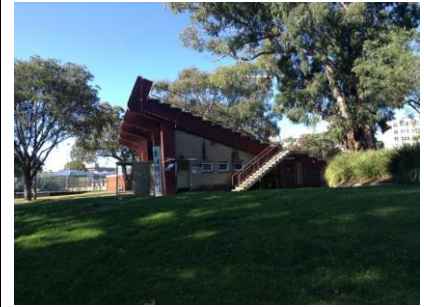
The building is contracted from brick veneer structure supported with timber framework. Access to the building is through concrete steps which leads to the main setting area.

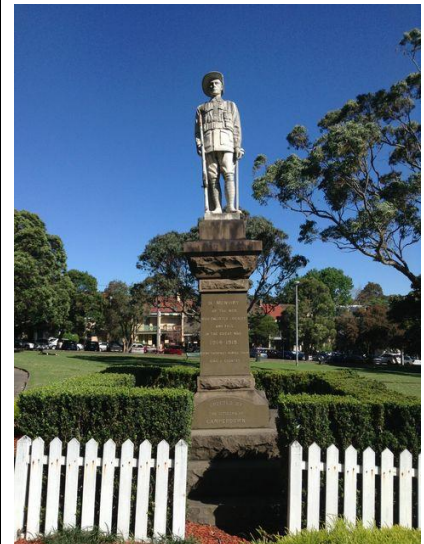
The structure is made of large sandstone blocks to contract a tall pillar. The base of the structure is concrete covered with terracotta tiles and sitting on top of the pillar is a marble ANZAC soldier.

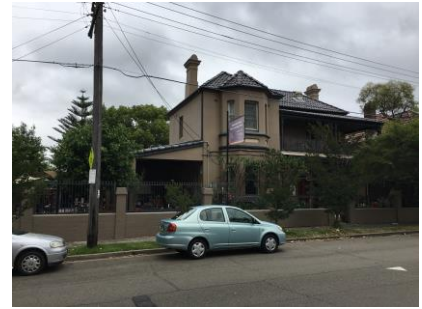
Cavendish Street Early Learning Centre, is a centre-based education and care service, approved by Department of Education & Communities children from birth to five years of age. The building has brick construction, with a timber and fibrolite roof, internal walls are render and ceilings are gyprock. The building is currently used as a childcare centre. The centre is made up of numerous small rooms, toilet areas, a kitchen area, office and storage areas.

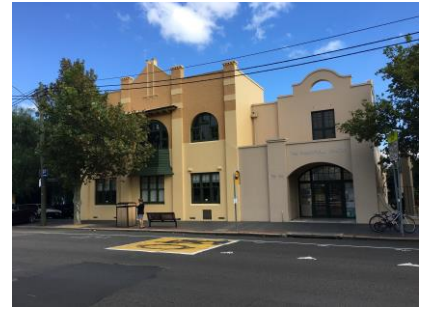
The Haberfield Centre comprising of the library, meeting rooms and part of premise is used by State Emergency Services. The building is a double storey complex, constructed of brick and yellow render.

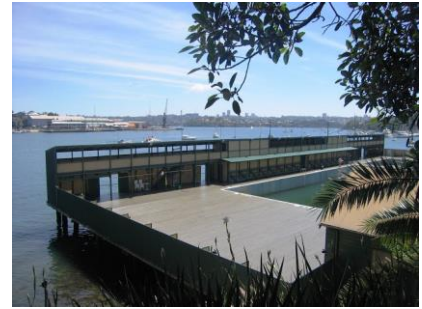
The complex is made up of different structures. The main amenities block is constructed of brick work and covered in yellow render. On either side of the main block, there is a timber structured rooms and storage facilities. Finally, the entire beach front is a sandstone seawall with cement mortar.

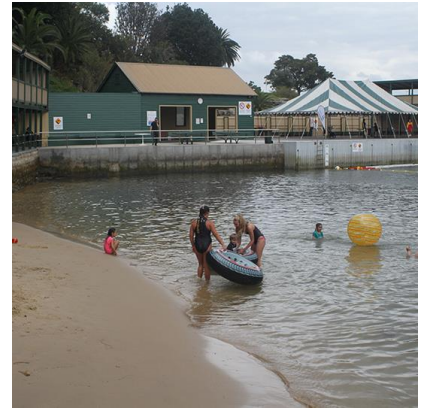
The complex is made up of different structures. The main amenities block is constructed of brick work and covered in yellow render. On either side of the main block, there is a timber structured rooms and storage facilities. Finally, the entire beach front is a sandstone seawall with cement mortar.

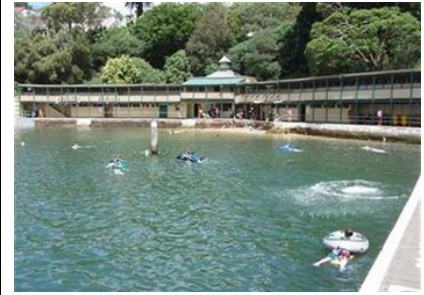
The complex is made up of different structures. The main amenities block is constructed of brick work and covered in yellow render. On either side of the main block, there is a timber structured rooms and storage facilities. Finally, the entire beach front is a sandstone seawall with cement mortar.

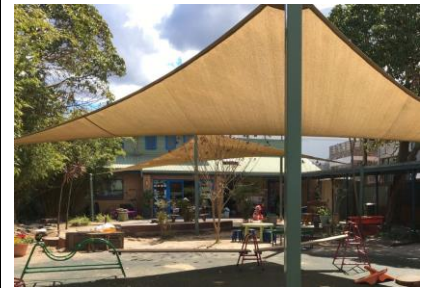
The building has brick construction, with a tile roof, internal walls and ceilings are gyprock. The building is currently being used as a childcare centre. The centre is made up of play rooms, a storage area, toilet areas for staff and children, office and a kitchen.

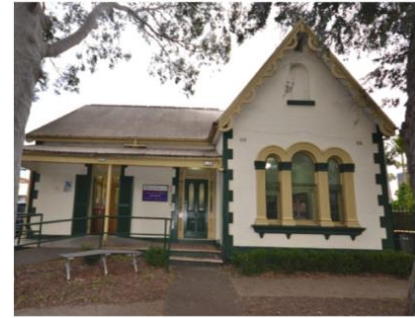
The building has brick construction, with a tile roof, internal walls are render and ceilings are gyprock. The building is currently used as a childcare centre. The centre is made up of several rooms, toilet areas and a kitchen area.

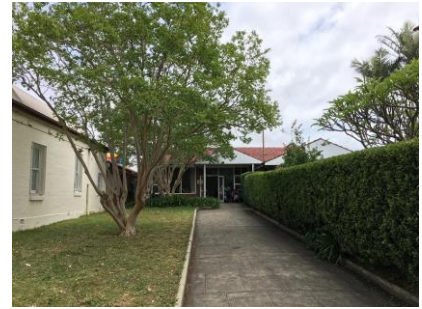
The property houses a number of regular hirers including Support and Playgroups. The building has brick construction, with a collarbone roof, internal walls are render and ceilings are gyprock. The building is currently used as a public hall. The hall is made up of numerous small rooms, toilet areas and a kitchen area.

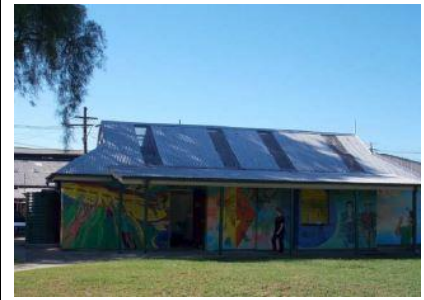
Easton park provides different amenities such as dressing sheds and toilets that are constructed of brick veneer and colourbond sheet roofing. Also, the wall from outside is covered with colourful artwork.

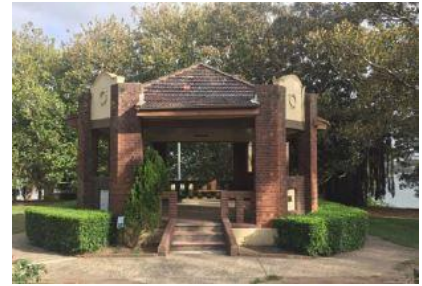
The bandstand is constructed of brick work and concrete staircases. The roof of the complex is made of colourbond sheets and timber framework. Finally, the stand is a double storey complex.

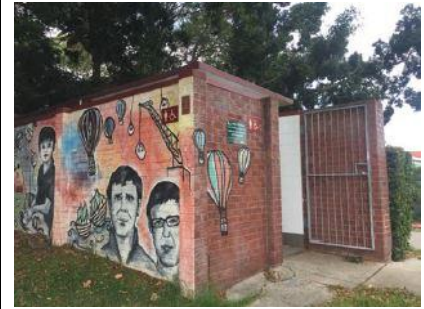
The toilet building is constructed from rendered brick, with a concrete slab roofing area.

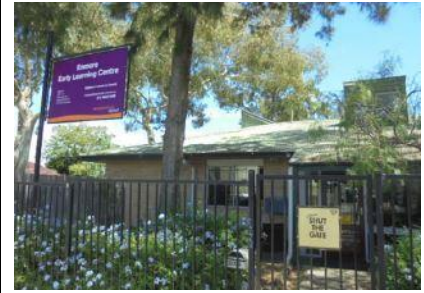
Centre-based education and care service, approved by Department of Education & Communities children from birth to five years of age. The building has brick construction, with a colorbond roof, internal walls and ceilings are gyprock. The building is currently being used as a childcare centre. The centre is made up of numerous small rooms, playrooms, staff areas, toilet areas, storage areas, a laundry and a kitchens.

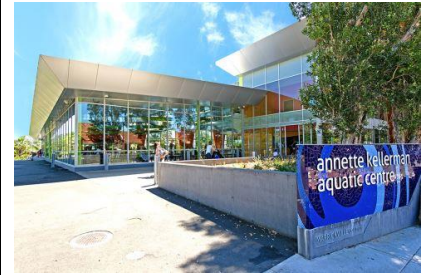
The Annette Kellerman Aquatic Centre – opened in 2010 after extensive redevelopment. The building has metal, fibrolite and terracotta construction, with a colorbond roof, internal walls and ceilings are gyprock. The centre is currently used for recreation. The centre is made up of a pool area, offices, storage areas, change rooms, toilet areas for male, female and disabled users and shower areas and a café.

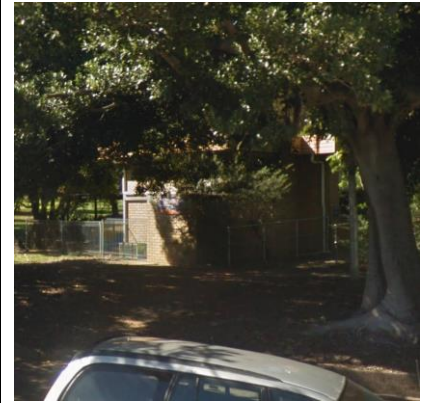
Not a licensed service. Used for community use. Including FDC. Does not generate income. The building has brick construction, with a colorbond roof, internal walls are render and ceilings are gyprock. The building is currently used as a community centre. The centre is made up of storage rooms, kitchen area, hall and toilet area.

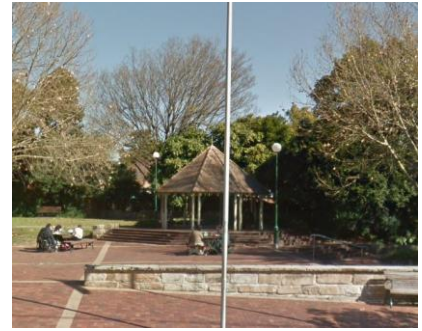
The entire structure of the rotunda is constructed of hardwood timber and reinforced by screws and bolts. The base of the structure is a concrete slab covered with terracotta tiles. The roof is constructed from slate tiles.

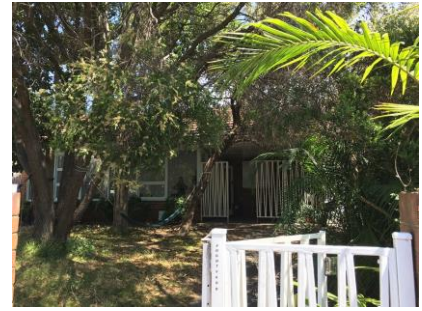
Lease in hold over. The building has brick construction, with a tile roof, internal walls are render and ceilings are gyprock. The building is currently used as a community centre. The centre is made up of numerous small rooms, toilet areas, a kitchen area and a reception area.

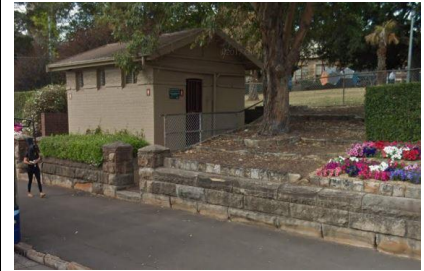
The toilet building is constructed from rendered brick, with a concrete slab roofing area. They provide bot male and female toilets at a very accessible area of the park.

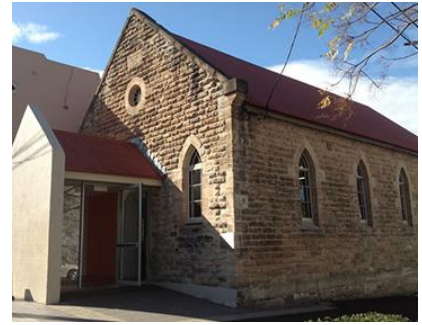
Historic sandstone building built in 1880 with stained glass windows. Site was originally a Methodist Church. Property was purchased from Harry Hannaford by LMC in 1975. Site was renovated in 2010 with the rear of the building modernised. Ongoing building issues related to water entering the building have taken place since this renovation. Subsequent new work was undertaken in 2015/2016 to rectify these issues. The Community Centre is available for community use and hire with 2 full-time staff providing ongoing activities and programs to meet community needs. Heffernan Hall has a maximum capacity of 80 persons, the Activity Room has a maximum of 30, Meeting Room and Lounge, 15 and 8 respectively and Therapy Room of 4. Heffernan Hall Size is 7.3m x 13.7m  
Heffernan Hall Size is 7.3m x 13.7m

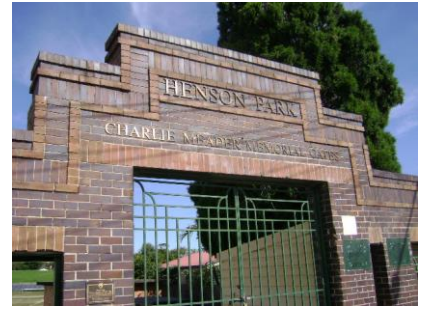
The gate is constructed of brick veneer and green steel railings

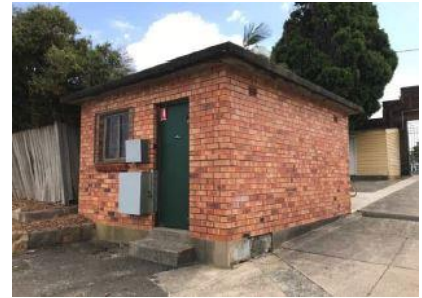
The amenities block is a single storey structure that is constructed of brick work and covered with yellow render. The roof is made of red colourbond sheets.

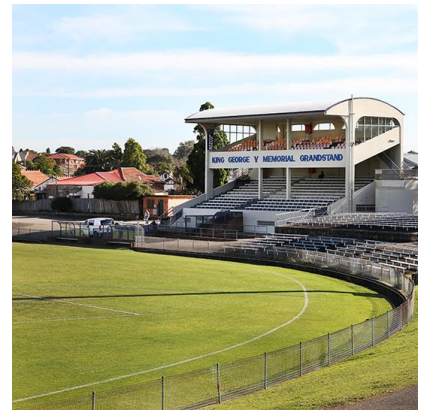
The grandstand structure is entirely constructed of concrete slabs which has been reinforced by steel bars. The roof of the stand is made of colourbond sheets and the benches aluminium.

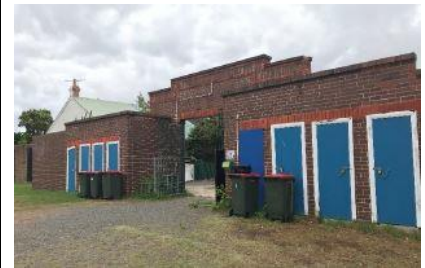
The toilet building is constructed from rendered brick, with a concrete slab roofing area. They provide bot male and female toilets at a very accessible area of the park.

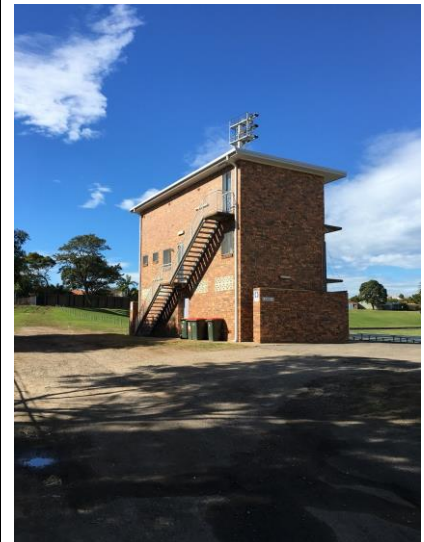
The building is a double storey complex constructed of brick veneer and colourbond sheet roof. The scoreboard is an digital laser board displaying numbers and writing.

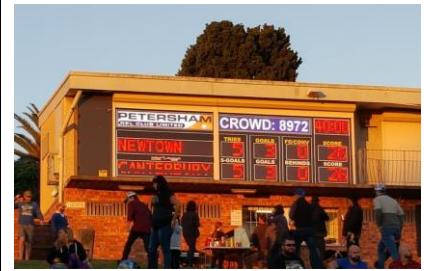
Building is "condemned".  
The building is a double storey complex constructed of brick veneer and colourbond sheet roof. The scoreboard is an digital laser board displaying numbers and writing.

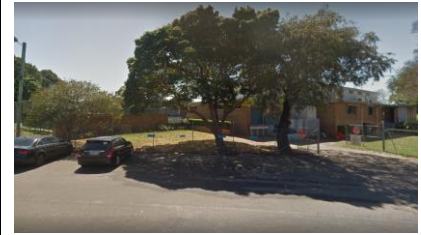
The building is a double storey complex, the bottom storey is constructed of brick veneer and colourbond sheet. The second storey is constructed of fibre board sheets and colourbond roof.

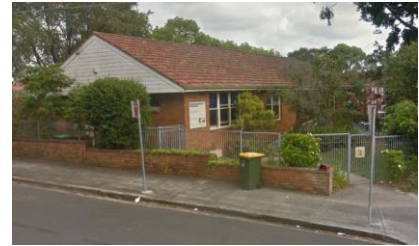
The building is a single storey complex which is constructed of brick veneer and clay roof tiles. The kindergarden has a outdoor play ground and resting area.

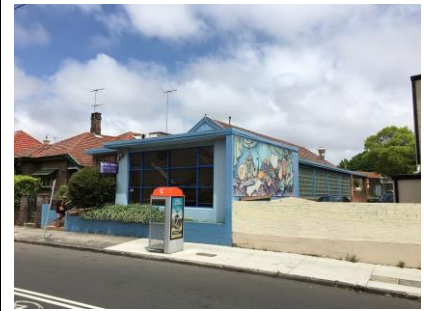
Current hire venue composed of small hall (16m x 6m) appropriate for up to 100 people. Suitable for meeting or dinner and dance.  
Air conditioned, full kitchen, close to public transport, with parking available  
Wheelchair accessible ramp at rear of hall via Fletcher Street. The building has brick construction, with a clay tile and colorbond roof, internal walls are render and ceilings are gyprock. The building is currently used as a public hall. The building is made up of two halls, toilet areas for male, female and disabled users, a kitchen area, dining area and storage area.

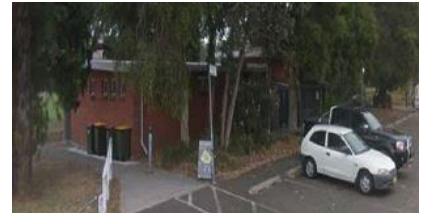
The toilet building is constructed from rendered brick, with a concrete slab roofing area. They provide bot male and female toilets at a very accessible area of the park.

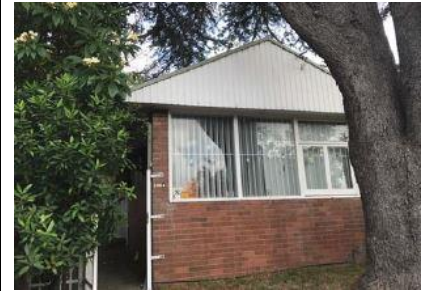
Space is small admin site. Lease in hold over Structural issues identified with tree roots impacting front yard. Brick fence cracked and shifting. The building has brick construction, with a steel roof, internal walls and ceilings are gyprock. The house is made up of three rooms, toilet areas, a kitchen and offices.

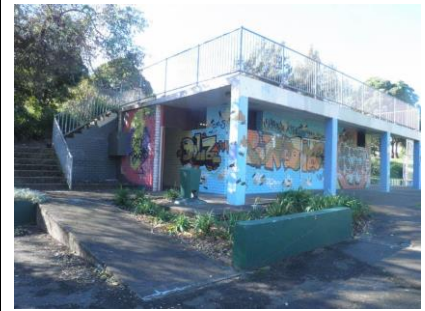
This complex is a double storey facility. The bottom level hold the public bathrooms which is constructed of brick work. All the brick work has colourful artwork on it.

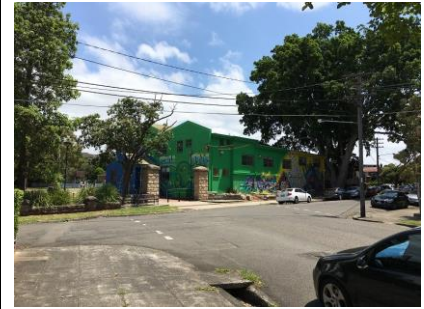
Building sits within Jarvie Park Leased site run by Marrickville Youth Resource Centre. Lot 1 in DP 947168. Roofing upgrade recently completed Issues with toilets and drainage  
Kitchen upgraded. The building has brick construction, with a colorbond roof, internal walls and ceilings are gyprock. The building is currently used as a community centre. The facility is made up of numerous small rooms, toilet areas for male, female and disabled users, a kitchen area, offices and storage areas.

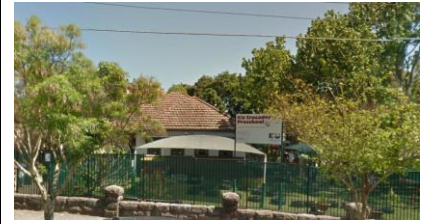
The building has fibrolite and shiplap construction, with a tile roof, internal walls and ceilings are plaster. The building is currently used as a childcare centre. The centre is made up of several small rooms, toilet areas for children and staff, a kitchen area, office and storage area.

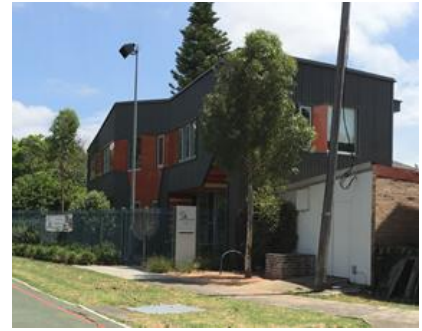
The building has colorbond construction, with a colorbond roof, internal walls and ceilings are gyprock. The centre is currently used as a child care centre. The centre is made up of numerous small rooms, playrooms, toilet areas for male, female and disabled users, kitchen areas, offices and storage areas.

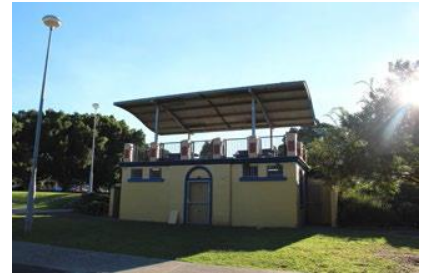
The toilet building is constructed from rendered brick, with a concrete slab roofing area. The building houses the toilets as well as an internal control room to house electrical equipment that regulates the various lighting elements within the park. There are both male, female and equal access toilets provided.

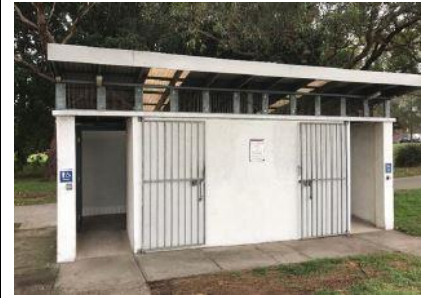
The toilet building is constructed from rendered brick, with a concrete slab roofing area. They provide bot male and female toilets at a very accessible area of the park.

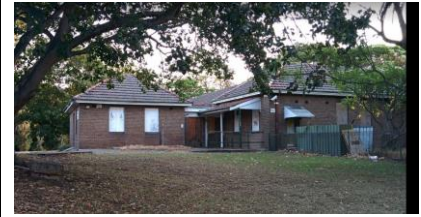
The amenity is a single level complex that is constructed of brick veneer and terracotta roof tiles and supported by timber framework.

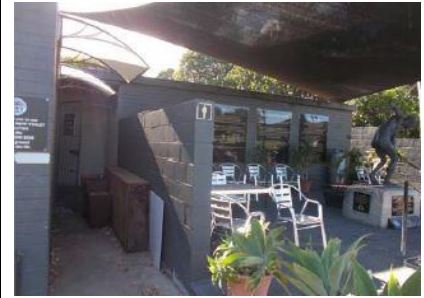
The toilet building is constructed from rendered brick, with a concrete slab roofing area. They provide bot male and female toilets at a very accessible area of the park.

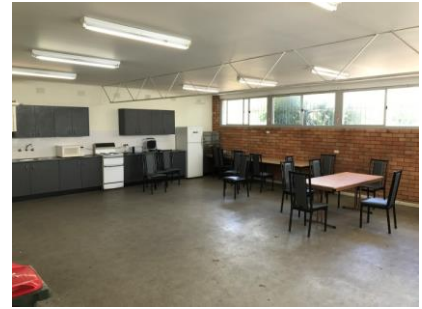
The amenities block at Leichhardt depot has recently been refurbished with new showers, wash basins and toilets. The locker room is quite small and confined. Despite the small area, the block is adequate as the site operates different shifts, with waste starting and finishing earlier than streetscapes. Cleaning seems to be an issue. There is a separate ladies facility with only one key available to the one female employee on site.

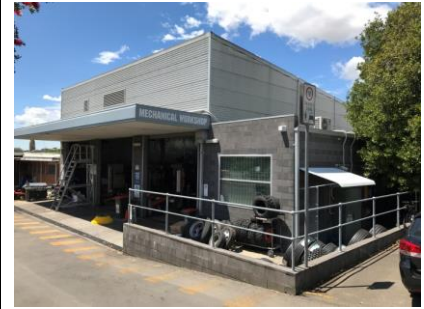
Large concrete block, open plan workshop with a small office and small separate storage area. Two mechanical hoists. Would benefit from added storage.

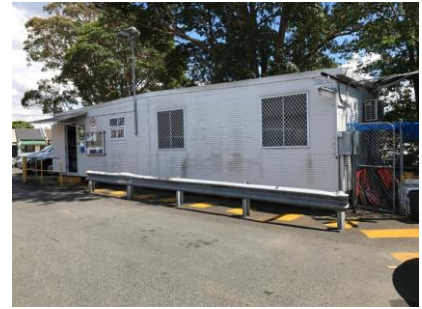
Demountable building in only fair condition. Small space. Should be re-located to improve parking and accessibility. Additional space required to accommodate operations.

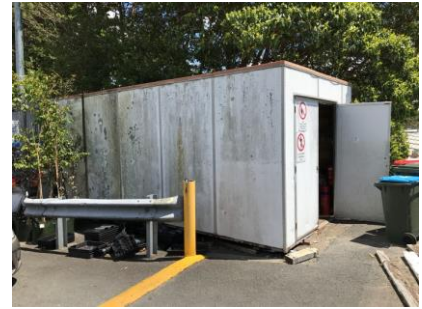
Shed appears to be an old converted coolroom. Divided into two separate ends, the shed provides storage for waste and streetscape pamphlets, banners, PPE etc.

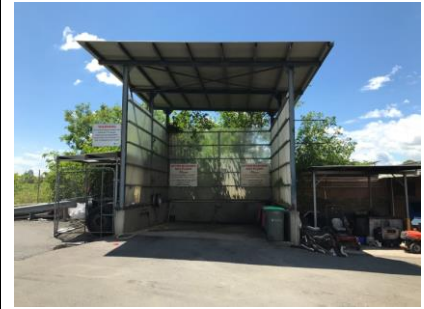
Steel framed structure with iron roof. High pressure water spray. Filtered drainage and sump pump with external waste water storage which is cleared by contractors on a monthly schedule.

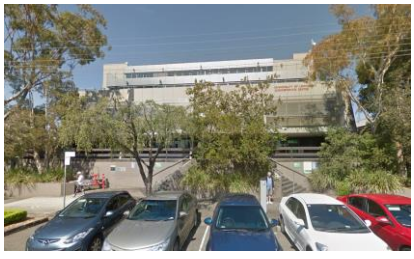
<p><b>Leichhardt Service Centre</b></p> <p><b>Description</b></p> <p>This administration building comprises of offices and council chambers. It also includes a customer service desk for members of the community to raise issues and questions. The building height was increased from one storey (and underground garage) to four storeys (and underground garage) in 2010.</p>

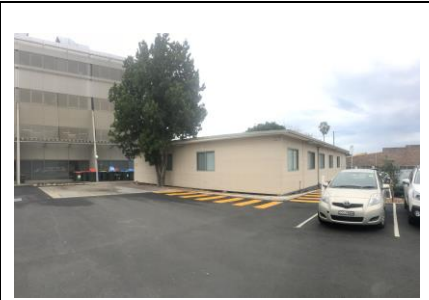
This administration building comprises of offices and council chambers. It also includes a customer service desk for members of the community to raise issues and questions. The building height was increased from one storey (and underground garage) to four storeys (and underground garage) in 2010.

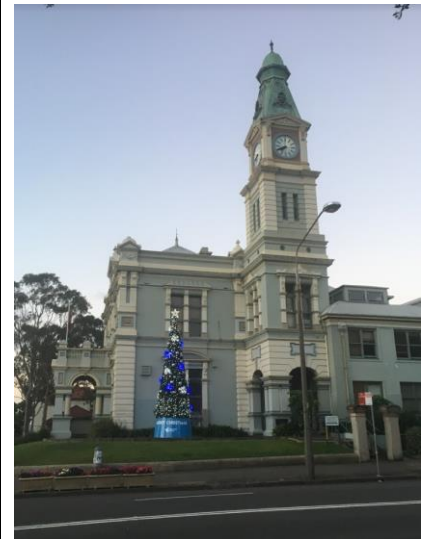
The Leichhardt Town Hall at No. 107 Norton Street is of high local historic, aesthetic and social significance as a good and largely intact Victorian Free Classical style Town Hall and Council building constructed in 1888. The current use includes Town Hall, administration offices, and chambers.

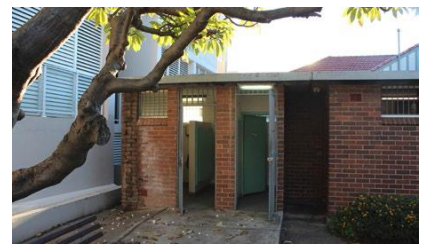
The building is a 1960s brick building with a flat roof. The building is configured into two areas, the public toilet and a Urban Transport 'break room'. Within the toilets there is one male and one female cubicle in separately labelled toilets.

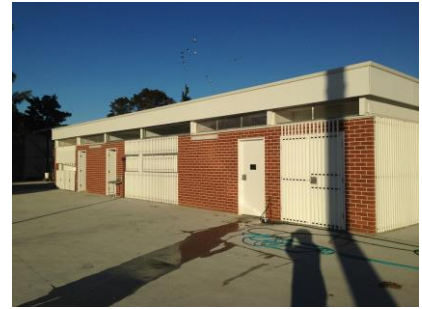
The site contains six natural lawn/grass, two flood lit synthetic grass and 4 hardcourt tennis courts. The lawn tennis courts are reserved for members and their guests, whilst the synthetic and hard are available for hire all year round.

This building was renewed in 2016.

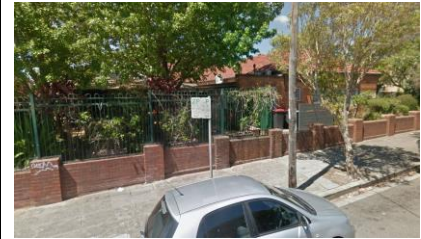
The building has brick construction, with a tile roof, internal walls are render and ceilings are gyprock. The building is currently used as a childcare centre. The centre is made up of playrooms, a staff area, a storage room, kitchen, toilet areas, offices and a laundry.

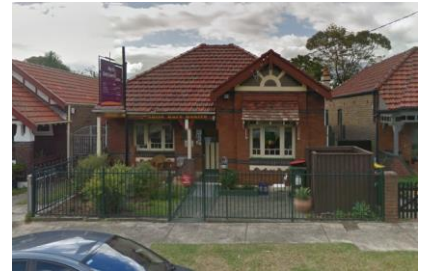
May Murray Early Learning Centre Centre-based education and care service, approved by Department of Education & Communities children from birth to five years of age. The building has brick construction, with a clay tile and colorbond roof, internal walls are render and ceilings are gyprock. The building is currently being used as a childcare centre. The centre is made up of play areas, toilet areas, a laundry and kitchen areas.

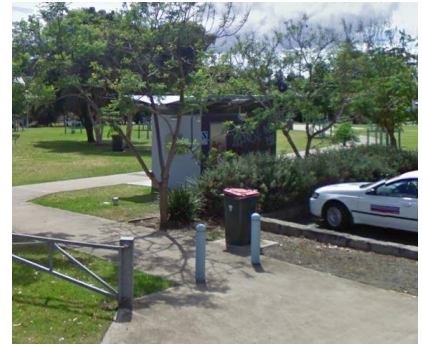
The toilet building is constructed from rendered brick, with a concrete slab roofing area. They provide bot male and female toilets at a very accessible area of the park.

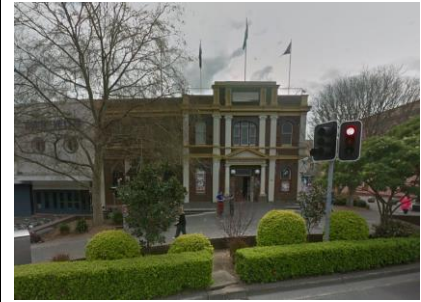
Part of lot 1817 in DP 996797 premises as Newtown Hall, The building has brick construction, with a metal sheet roof, internal walls and ceilings are plaster. The building is currently being used as a public hall. The building is made up of numerous small rooms, toilet areas for male, female and disabled users, kitchen areas and offices.

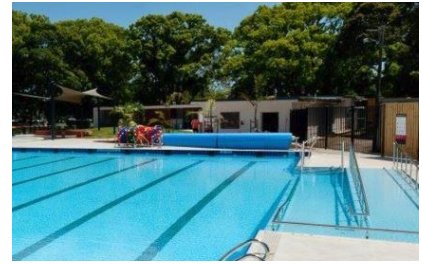
25m pool with inclusive access and kids splash pool and associated change and toilet facilities. Passive recreation facilities including water play, bbq and grassed areas.  
Small office and reception building linked to café which has serves both the pool and the park during the opening season and the park in the off season.

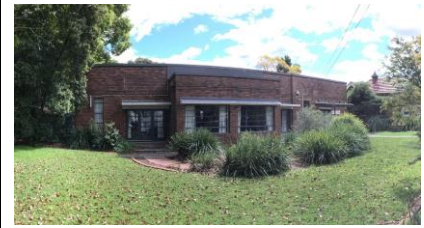
The building has brick construction, with a colorbond roof, internal walls are render and ceilings are gyprock. The centre is currently used as a childcare centre. The centre is made up of playrooms, a staff area, toilet areas, kitchen areas, offices and a storage area.

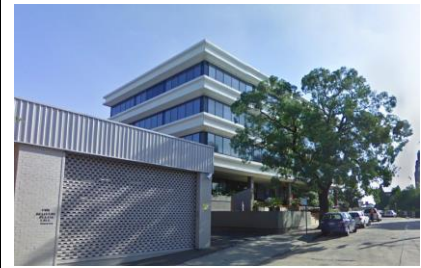
The building has brick construction, with a aluminium and colorbond roof, internal walls are render and ceilings are particle board. The building is currently used for administration. The Chambers are made up of numerous small rooms, offices, storage areas, kitchen areas, toilet facilities for male and female users, meeting rooms and a car park area.

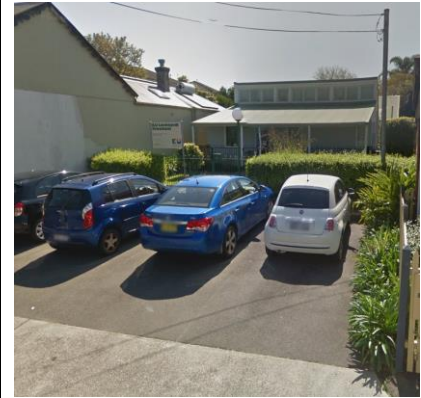
The building is constructed by single brick with aqua colour render/ the roof is made of grey colourbond sheets.

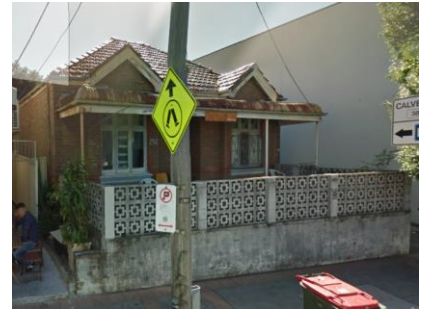
The building has shiplap construction, with a tile roof, internal walls are render and ceilings are gyprock. The house is made up of numerous small rooms.

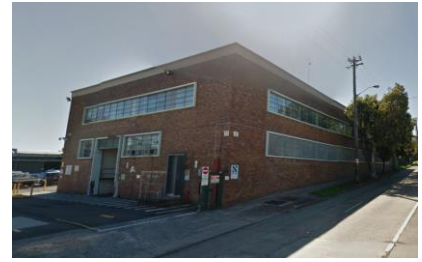
Two storey brick building, mostly office space with councils store on ground level. Recently renovated with good facilities and lunchroom. The building has colorbond construction, with a colorbond roof, internal walls are gyprock and ceilings are suspended panels. The building is currently used for administration. The building is made up of numerous small rooms, toilet areas for male and female users, a kitchen area and offices.

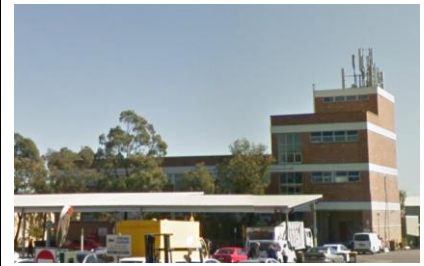
Two storey brick building with recently renovated offices on top floor, trades workshop and storage on ground floor. Renovation and re-purposing work performed for co-location so building is in good condition. The building has brick construction, with a colorbond roof, internal walls and ceilings are gyprock. The building is currently used as a depot. The building is made up of numerous small rooms, toilet areas for male, female and disabled users, a kitchen area, offices and storage areas.

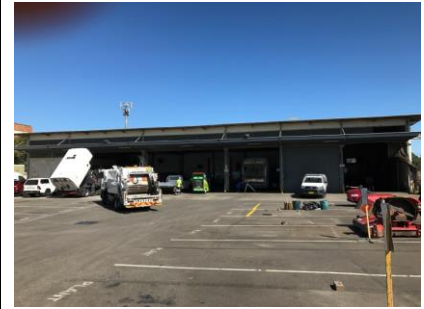
The building has metal construction, with a steel roof and internal walls are gyprock. The building is currently used as a depot. The centre is made up of offices, a toilet area, workshop, storage area and breakroom.

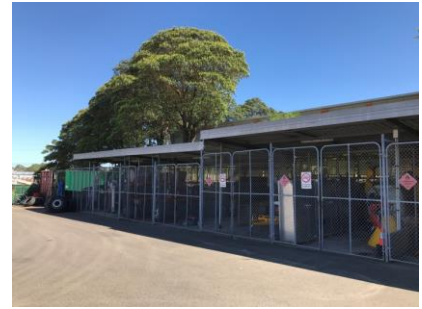
Basic iron roof supported by steel frame, separated into bays with lockable gates.

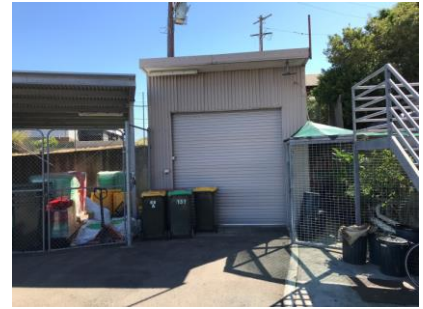
Corrugated iron clad shed with roller shutter front entry. The site has multiple assets that are enclosed with wire mesh fences and has a colorbond roof. It is currently used as a storage facility.

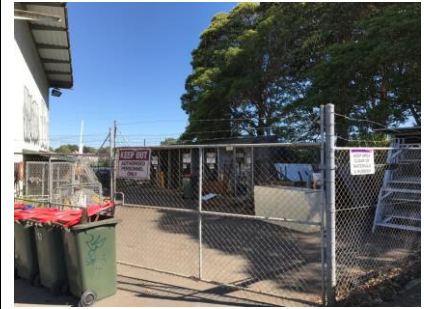
Basic iron roof with side and rear walls and open front. Secured by locking gate at perimeter fence.

This shed will be rebuilt for use by trades in the near future.

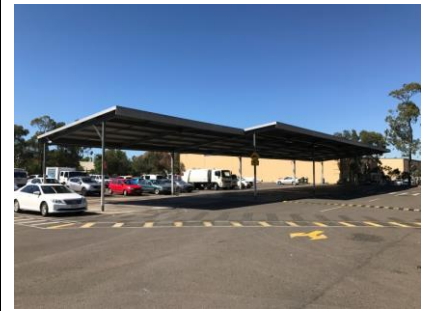
Metal roof supported by steel framework.

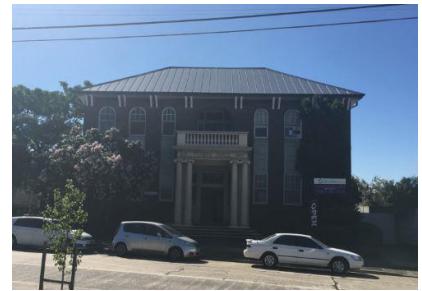
The building comprises the library, community rooms and the town hall. there are a number of kitchens within the facility. The building has brick construction, with a tile roof, internal walls are render and ceilings are gyprock. The building is currently being used as a public hall. The centre is made up of numerous small rooms, toilet areas for male, female and disabled users, kitchen areas, and storage areas.

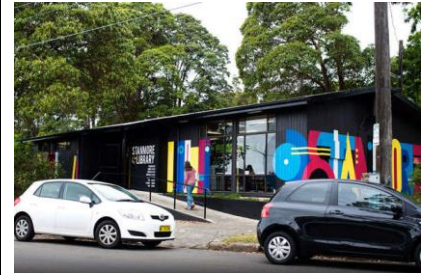
Very popular small neighbourhood library similar to a demountable. The building was always meant to be replaced and is currently the only community facility in Stanmore. The building has weatherboard construction, with a colorbond roof, internal walls and ceilings are gyprock. The building is currently used as a library. The building is made up of a library area, work room and toilet area.

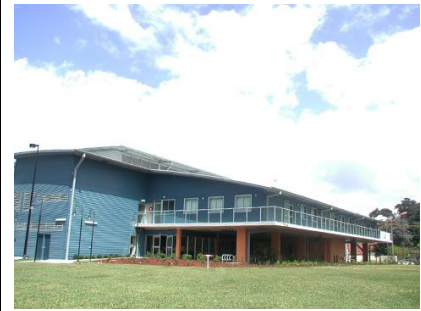
The building has colorbond construction, with a colorbond roof, gyprock internal walls and ceilings are plaster. The centre is currently used for recreation. The centre is made up of numerous small rooms, toilet areas for male, female and disabled users, kitchen areas, offices, cafe and storage areas.

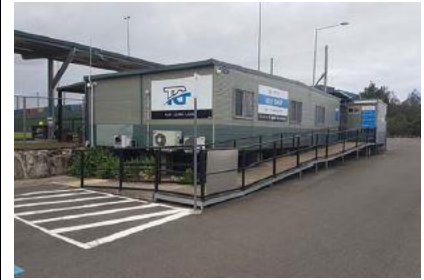
The buildings have colorbond construction, with a colorbond roof, internal walls and ceilings are plywood. The buildings are currently used for recreation. The demountables are made up of a reception area, kitchen area, office area and toilet areas for male, female and disabled users.

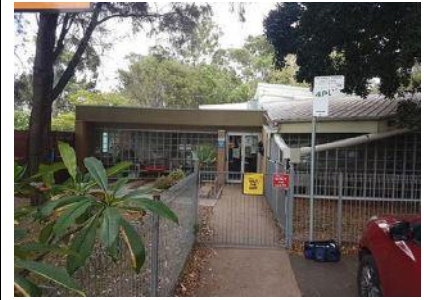
Centre-based education and care service, approved by Department of Education & Communities children from birth to five years of age. The building has brick construction, with a fibrolite and colorbond roof, internal walls and ceilings are gyprock. This is a home converted into a childcare centre. The Centre is old however still functional. The centre is made up of numerous small rooms, toilet areas for male, female and disabled users, a kitchen area, office and storage areas.

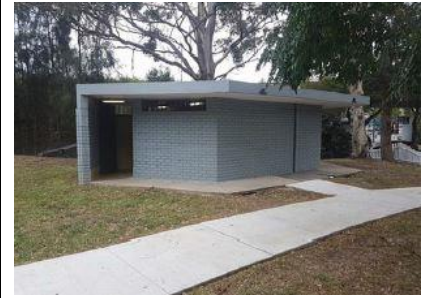
The building is constructed of brick cladding and a suspended slab roof. The toilets are configured with male and female toilet located at each end of a brick building. The male toilets have one cubicle and one trough style urinal. The female toilets have two cubicles. The has stainless steel fixtures and fittings. The toilets have plastic seats and lids. Basic hand wash facilities are provided, but no hand drying / paper towel. Sharps disposal units are provided. The roof and walls are showing signs of structural weakness and a detailed assessment is recommended.

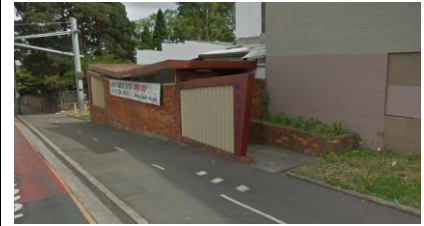
The toilet block is constructed by single brick veneer and a red clay roof tiles supported by timber framework.

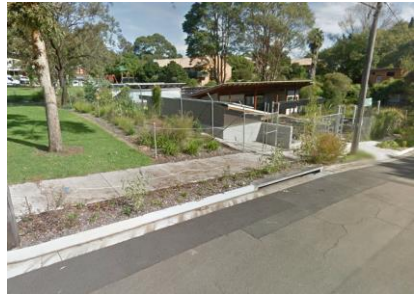
**Rozelle Bay Community Native Nursery Greenhouse**  
**Description**  
 A Stone Cottage that incorporates elements of environmentally sustainable design. Toilet on site is compostable.  
 Melaleuca Room Capacity of 30 People. Grevillia Room Capacity of 10 People  
 In 2017 and 2018, two rooms have been used for Artist-In-Residence Programs

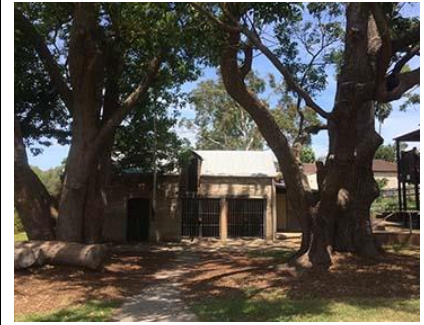
A Stone Cottage that A covered area adjoining to Whites Creek Cottage. Maximum Capacity of 20 with covered area with bench and sink.
