Addison Road Early Learning Centre

Description

Centre-based education and care service. The building has brick construction, with a tile roof, internal walls are render and ceilings are gyprock currently used as a childcare centre. The centre is made up of several small rooms, staff areas, storage areas, playrooms, kitchen areas and toilet areas.

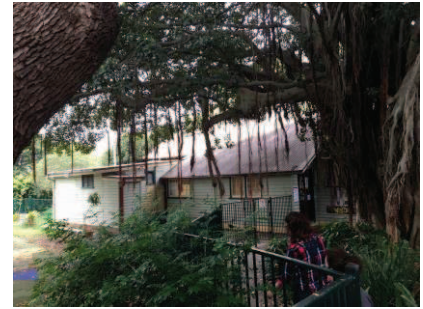
Centre-based education and care service, approved by Department of Education & Communities children of school age. The building has brick construction, with a tile roof, internal walls and ceilings are hardboard. The building is currently used as a childcare centre. The centre is made up of an office, eating and play areas, storage room, toilet area and kitchen.

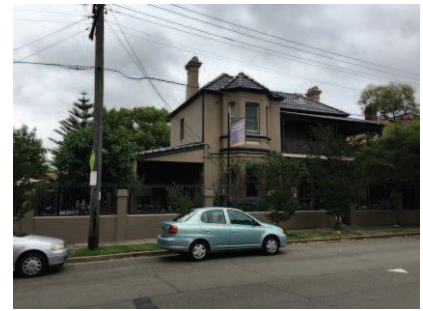
Cavendish Street Early Learning Centre, is a centre-based education and care service, approved by Department of Education & Communities children from birth to five years of age. The building has brick construction, with a timber and fibrolite roof, internal walls are render and ceilings are gyprock. The building is currently used as a childcare centre. The centre is made up of numerous small rooms, toilet areas, a kitchen area, office and storage areas.

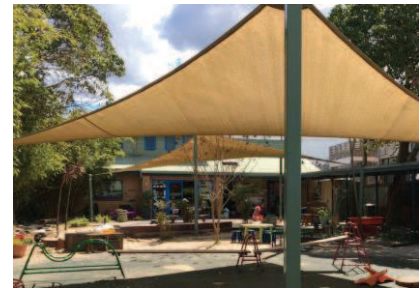
The building has brick construction, with a tile roof, internal walls and ceilings are gyprock. The building is currently being used as a childcare centre. The centre is made up of play rooms, a storage area, toilet areas for staff and children, office and a kitchen.

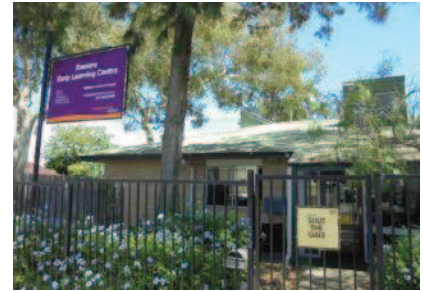
Centre-based education and care service, approved by Department of Education & Communities children from birth to five years of age. The building has brick construction, with a colorbond roof, internal walls and ceilings are gyprock. The building is currently being used as a childcare centre. The centre is made up of numerous small rooms, playrooms, staff areas, toilet areas, storage areas, a laundry and a kitchens.

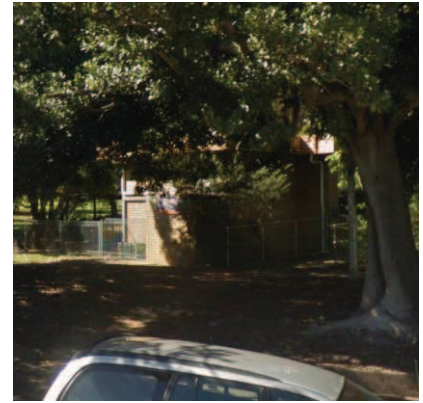
Not a licensed service. Used for community use. Including FDC. Does not generate income. The building has brick construction, with a colorbond roof, internal walls are render and ceilings are gyprock. The building is currently used as a community centre. The centre is made up of storage rooms, kitchen area, hall and toilet area.

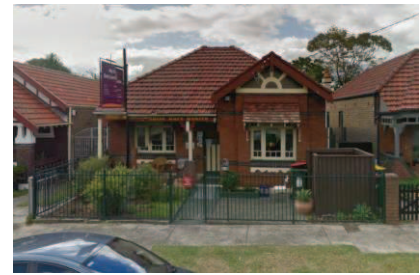
May Murray Early Learning Centre Centre-based education and care service, approved by Department of Education & Communities children from birth to five years of age. The building has brick construction, with a clay tile and colorbond roof, internal walls are render and ceilings are gyprock. The building is currently being used as a childcare centre. The centre is made up of play areas, toilet areas, a laundry and kitchen areas.

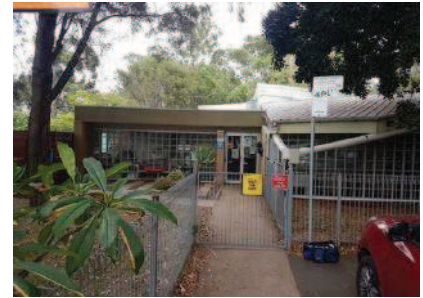
Centre-based education and care service, approved by Department of Education & Communities children from birth to five years of age. The building has brick construction, with a fibrolite and colorbond roof, internal walls and ceilings are gyprock. This is a home converted into a childcare centre. The Centre is old however still functional. The centre is made up of numerous small rooms, toilet areas for male, female and disabled users, a kitchen area, office and storage areas.
