Chrissie Cotter Gallery

Description

The building has brick construction, with a aluminium roof, internal walls and ceilings are gyprock. The building is currently used as a public hall. The Hall is made up of the main hall, a kitchen, lobby and foyer areas, a room and toilet areas for male, female and disabled users.

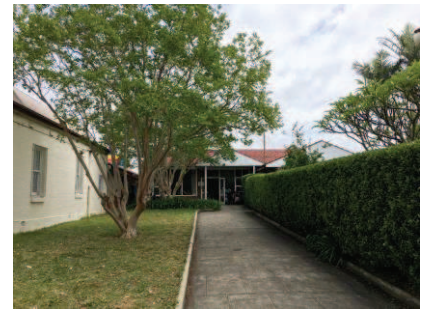
Seaview Street Hall

The property houses a number of regular hirers including Support and Playgroups. The building has brick construction, with a collarbone roof, internal walls are render and ceilings are gyprock. The building is currently used as a public hall. The hall is made up of numerous small rooms, toilet areas and a kitchen area.

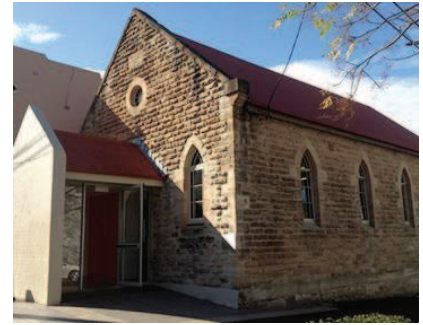
Hannaford Community Centre

Historic sandstone building built in 1880 with stained glass windows. Site was originally a Methodist Church. Property was purchased from Harry Hannaford by LMC in 1975. Site was renovated in 2010 with the rear of the building modernised. Ongoing building issues related to water entering the building have taken place since this renovation. Subsequent new work was undertaken in 2015/2016 to rectify these issues. The Community Centre is available for community use and hire with 2 full-time staff providing ongoing activities and programs to meet community needs. Heffernan Hall has a maximum capacity of 80 persons, the Activity Room has a maximum of 30, Meeting Room and Lounge, 15 and 8 respectively and Therapy Room of 4. Heffernan Hall Size is 7.3m x 13.7m
Heffernan Hall Size is 7.3m x 13.7m

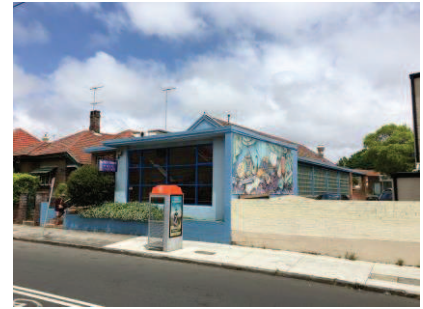
Herb Greedy Hall

Current hire venue composed of small hall (16m x 6m) appropriate for up to 100 people. Suitable for meeting or dinner and dance. Air conditioned, full kitchen, close to public transport, with parking available
Wheelchair accessible ramp at rear of hall via Fletcher Street. The building has brick construction, with a clay tile and colorbond roof, internal walls are render and ceilings are gyprock. The building is currently used as a public hall. The building is made up of two halls, toilet areas for male, female and disabled users, a kitchen area, dining area and storage area.

Concrete Stairs - Tread Non-Slip Surface Failure - Nosing missing/cracked
Store (adj to main hall) - Gyprock Lining - Moisture Damage - Moisture damage. Leaks when it rains
Store (adj to main hall) - Paint Finish - Water Damaged/Mould Issues - Moisture damage
Main Hall - Fluorescent Lights - Light Not Working - Light not working
Main Hall - Downlights - Light Not Working - Light not working
Kitchen - Render - Cracked - Large cracks in render
Disable Toilet - Toilet-China Bowl/Cistern - Rubber Cone - Leaking
