**Balmain Town Hall**

**Description**

Balmain Library is part of the Balmain Town Hall Building complex. Comprising of the Town Hall, the meeting rooms, the library, the archive, the caretaker's residence and courtyard plus gardens.

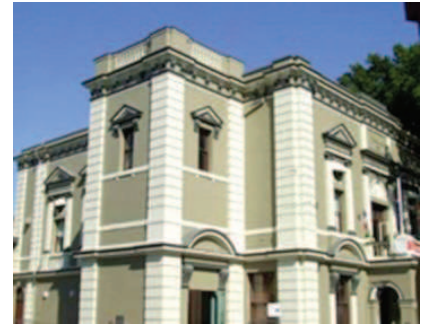
This is a heritage listed building dating from 1888; when Balmain was a municipality. Some external walls may not be tampered with at all, particularly the front façade and eastern exterior.

In 2009 the entire building was refurbished at a cost of approximately \$4.9 million; increasing the library floor space to 557m<sup>2</sup>. Approximately 12,000 people visit the library per month.

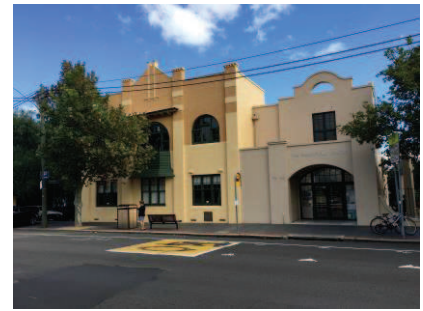
The Haberfield Centre comprising of the library, meeting rooms and part of premise is used by State Emergency Services. The building is a double storey complex, constructed of brick and yellow render.

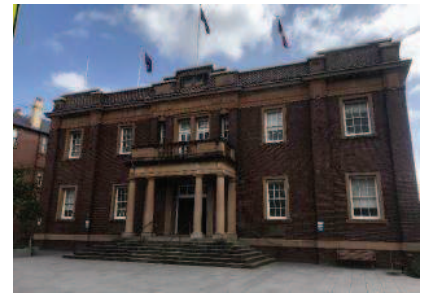
The Marrickville Town Hall was built in 1879 and is Heritage listed; with the second storey being added in 1883. The town hall is currently used as a public hall and also includes Marrickville Library. The town hall is made up of numerous small rooms, offices, storage areas, library areas, a kitchen area and toilet areas for male, female and disabled users. The building has brick construction, with a concrete slab roof, internal walls are render and ceilings are plaster. Marrickville Library due to vacate 2019 and move into the new Marrickville Library. The building has brick construction, with a concrete slab roof, internal walls are render and ceilings are plaster. The town hall is currently used as a public hall and also includes Marrickville Library. The town hall is made up of numerous small rooms, offices, storage areas, library areas, a kitchen area and toilet areas for male, female and disabled users.

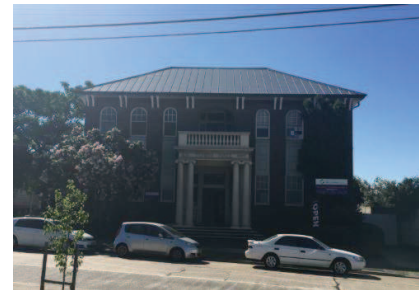
The St Peter's Town Hall was built in 1927; comprises of the library, meeting rooms and the archive. Recently a new roof and sound proof as the building is directly under the Sydney flight path.

The building comprises the library, community rooms and the town hall. there are a number of kitchens within the facility. The building has brick construction, with a tile roof, internal walls are render and ceilings are gyprock. The building is currently being used as a public hall. The centre is made up of numerous small rooms, toilet areas for male, female and disabled users, kitchen areas, and storage areas.

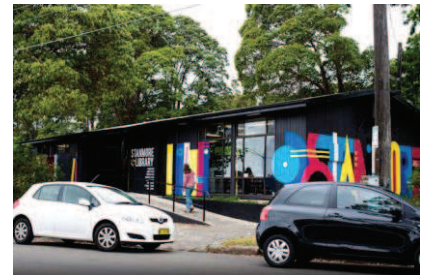
Very popular small neighbourhood library similar to a demountable. The building was always meant to be replaced and is currently the only community facility in Stanmore. The building has weatherboard construction, with a colorbond roof, internal walls and ceilings are gyprock. The building is currently used as a library. The building is made up of a library area, work room and toilet area.
