Dawn Fraser Pool Northern Pavilion

Dawn Fraser Pool Open Shed

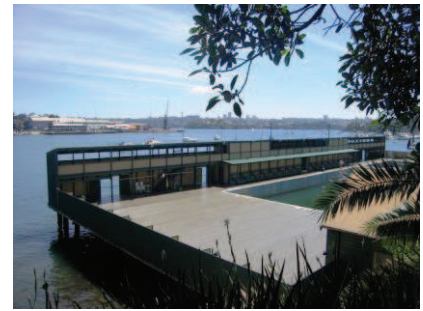
The complex is made up of different structures. The main amenities block is constructed of brick work and covered in yellow render. On either side of the main block, there is a timber structured rooms and storage facilities. Finally, the entire beach front is a sandstone seawall with cement mortar.

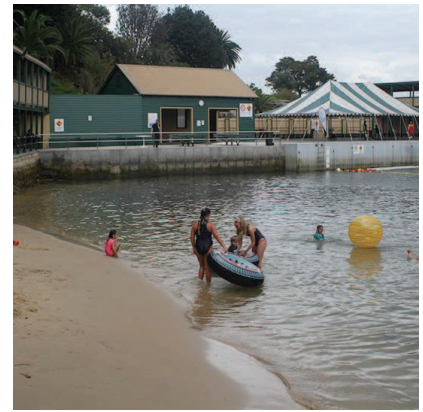
The complex is made up of different structures. The main amenities block is constructed of brick work and covered in yellow render. On either side of the main block, there is a timber structured rooms and storage facilities. Finally, the entire beach front is a sandstone seawall with cement mortar.

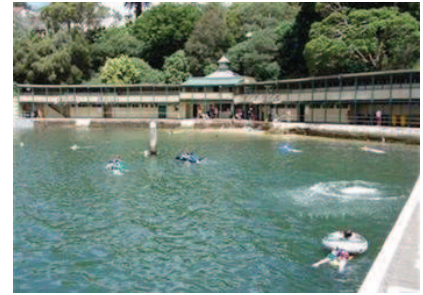
The complex is made up of different structures. The main amenities block is constructed of brick work and covered in yellow render. On either side of the main block, there is a timber structured rooms and storage facilities. Finally, the entire beach front is a sandstone seawall with cement mortar.

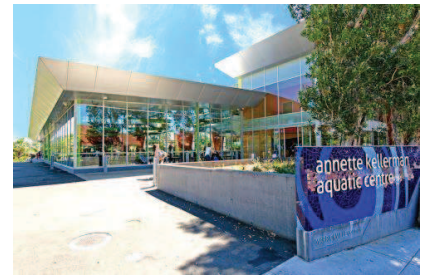
The Annette Kellerman Aquatic Centre – opened in 2010 after extensive redevelopment. The building has metal, fibrolite and terracotta construction, with a colorbond roof, internal walls and ceilings are gyprock. The centre is currently used for recreation. The centre is made up of a pool area, offices, storage areas, change rooms, toilet areas for male, female and disabled users and shower areas and a café.

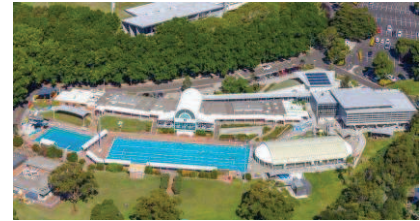
Leichhardt Park Aquatic Centre is a friendly fitness centre that offers a wide range of facilities that caters for the diversity of the local community. It is located in the Leichhardt Park area nearby the Leichhardt Park Oval 1 and 2 and is comprised of a number indoor and outdoor pools and supporting buildings. These buildings include a diving tower, gymnasiums, cafe, staff room, lifeguard shelter, first aid room, plant rooms and a cogeneration building.

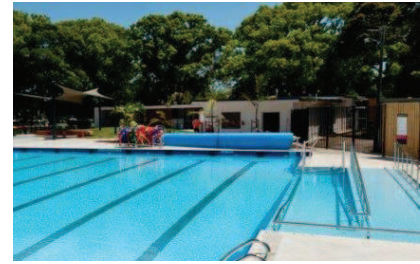
25m pool with inclusive access and kids splash pool and associated change and toilet facilities. Passive recreation facilities including water play, bbq and grassed areas.

Small office and reception building linked to café which has serves both the pool and the park during the opening season and the park in the off season.

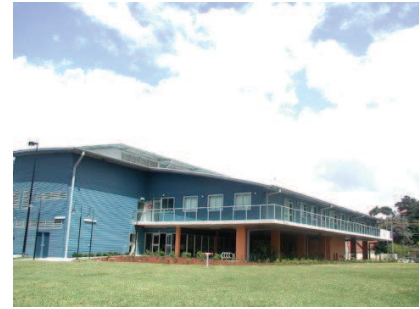
The building has colorbond construction, with a colorbond roof, gyprock internal walls and ceilings are plaster. The centre is currently used for recreation. The centre is made up of numerous small rooms, toilet areas for male, female and disabled users, kitchen areas, offices, cafe and storage areas.
